Weld Failure Analysis: A Case Study

Wesley Wang, Senior Engineer
EWI

Case Study

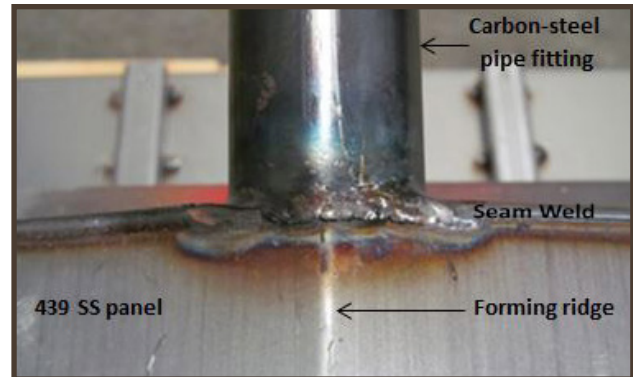
After a 439 stainless steel (SS) oil tank was heated to a high temperature in service, a through-thickness crack was found in a circumferential weld between a carbon-steel pipe fitting and the 439 stainless steel (SS) tank panel. This surface-breaking crack can be clearly seen in Figure 1. The chemical compositions of the dissimilar base materials are provided in Table 1.

Figure 1: Weld joint between the carbon steel pipe fitting and the SS tank panel.

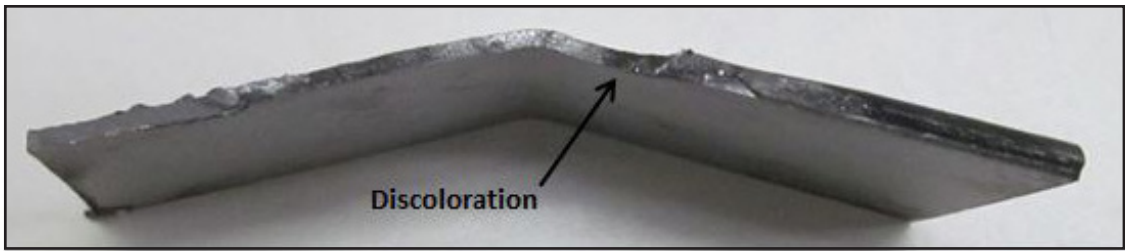
The consumable specified for manual gas tungsten arc welding (GTAW) was a 309L SS rod using argon shielding gas. The cracked portion of the joint was extracted and opened to reveal the crack surface (Figure 2). From the discoloration of the

surface, it was determined that the crack initiated at the location where the pipe fitting met the seam weld of the SS tank. This examination also revealed that complete joint penetration was not achieved.

SEM Energy-dispersive X-ray spectroscopy (SEM-EDS) was then used to identify the local chemical composition (Table 2) of the fractured weld surface. This examination revealed that the weld contained a significant amount of oxygen (O). A layer of chromium oxide residue was also found on the joint groove surface, indicating contamination due to improper cleaning of the joint after plasma cutting prior to welding.

Figure 2: Opened crack surface showing a discoloration site to be cracking origin.

It was concluded that chromium oxide contamination from the upstream plasma cutting

operation – a problem easily solved with a light grinding – initiated the crack under a local stress concentration. Secondary cracking was caused by high residual stresses in the austenite/ferrite duplex matrix.

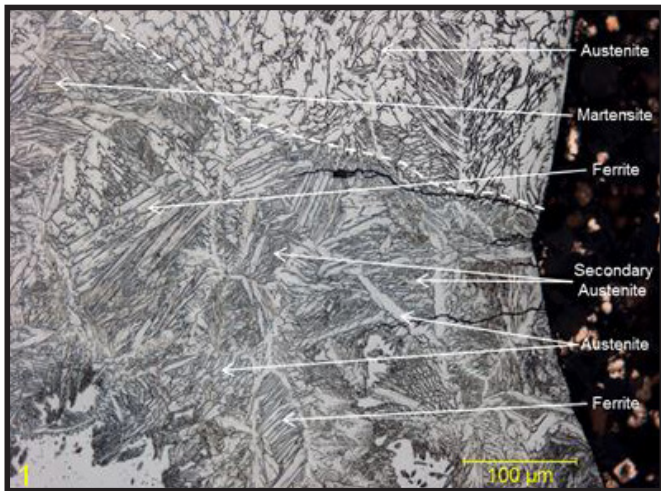
Microstructural evaluation revealed a $\gamma+\delta$ duplex microstructure at the toe of the cracked weld at the SS panel side (Figure 3). This was a significant finding as the different thermal-expansion coefficients of austenite and ferrite can lead to significantly increased local stresses.

Figure 3: Micrograph of the weld toe showing the austenite and ferrite duplex microstructure.
