# Durability Testing of Ceramic Coatings for Indirect Resistance Heat Treating in Vehicle Lightweighting Applications

Warren Peterson and Jerry E. Gould  
EWI

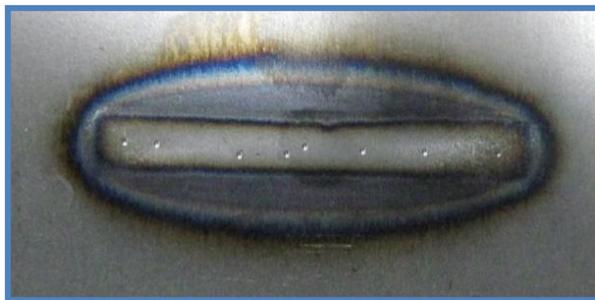
**Figure 1. DP780 Sheet Steel Sample Following Local Indirect Resistance Heat Treatment**

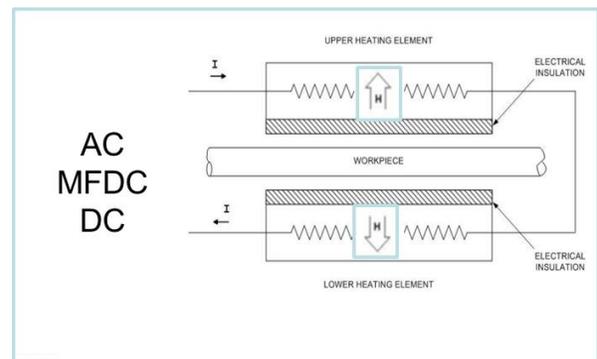
**Figure 2. Schematic Illustration of the Indirect Resistance Heat Treating Process**

IRHT is a method of locally tailoring metallurgical or physical changes in a workpiece by the indirect conduction of heat from a set of electrically isolated, but thermally conductive resistive heating elements followed by rapid quenching. The method has previously been demonstrated for indirect resistance brazing.<sup>(1)</sup> A sample heated using this technology is shown in Figure 1. High electrical currents are used to generate resistive heat within the metallic heating elements of a specified geometry. A ceramic coating on the heating element acts as an electrical barrier, but allows heat transfer to and from the workpiece. Water-cooled copper tooling is used to position the heating element, provide electrical contact, and cool the element to prevent overheating. On cessation of current flow, heat in the workpiece flows back through the ceramic coating into the heating element, and to the copper tooling. A schematic of this process is illustrated in Figure 2. The resulting thermal cycle provides the desired metallurgical or physical transformations. The process is closely related to DRHT, described elsewhere.<sup>(2)</sup> Laboratory experiments have illustrated the capability to produce locally hardened zones with appropriate microstructures. Locally hardened zones are used to strengthen components where needed, enabling a reduction in overall thickness. Locally softened zones are also possible, creating crumple zones in crash energy management systems.

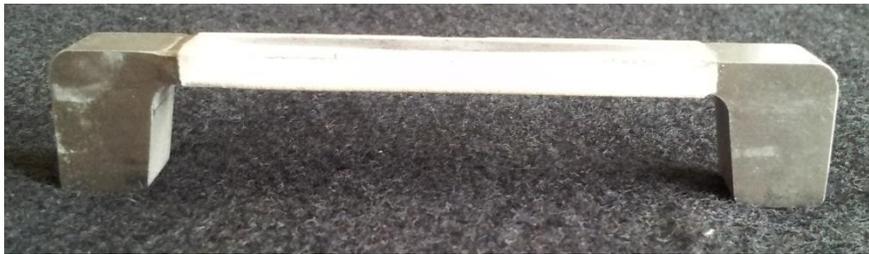
**Figure 3. An Example of an Ceramic Coated TZM Heating Element for the Indirect Resistance Heat Treatment Process**

In this study, Mo-TZM electrodes have been used as the resistive heating element material for these trials. The IRHT elements shown in Figure 3 were developed for heating an extended area (10×50 mm) of sheet metal samples.

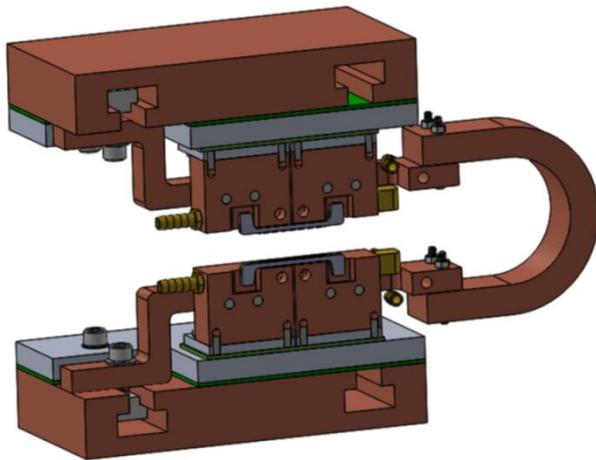
**Figure 4. Schematic Cutaway Section of the IRHT Tooling Used in This Investigation**

The basic design of the IRHT tooling is provided in Figure 4. This tooling provided a series current path between two opposing IRHT heating elements. The tooling also included direct water cooling of copper support tooling under each heating element. This tooling was then placed within a standard 100-kVA AC pedestal resistance welding system. An image of one heating element as constrained by the tooling is provided in Figure 5.

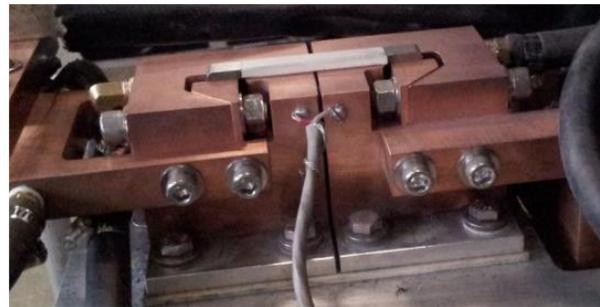
**Figure 5. The Coated Mo-TZM Heating Element Positioned by the Tooling in the Pedestal Welding Machine**

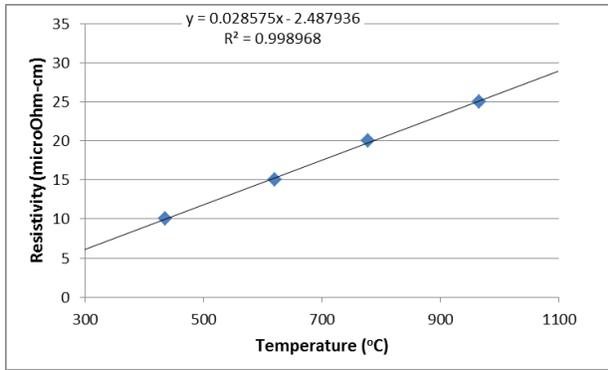
**Figure 6. Linear Relationship between Electrical Resistivity and Temperature for TZM Material**

Measurement of the IRHT process temperature was done by collecting the dynamic resistance of the TZM elements themselves. For the TZM material, temperature varies linearly with resistance. Temperature-resistivity data for Mo-TZM is provided in Figure 6. The temperature was correlated against both attached thermocouples and thermal imaging. Dynamic resistance was calculated by monitoring the current and voltage across a heating element (voltage lead placement shown in Figure 5) and calculating the resistance at the instantaneous peak of the current waveform. The temperature profile of the TZM elements during heating was adjusted using a pulsation schedule. This facilitated profiles that heated rapidly and remained nominally steady over the desired processing time. An example of a 33-s heating cycle is shown in Figure 7. This graph shows the temperature readings from both the thermocouple and the IR camera overlaid with the AC current (represented by a voltage reading). Resistances during cooling were assessed by periodic monitoring of small, dispersed pulses of low current. This again was compared to the values observed using a thermocouple.

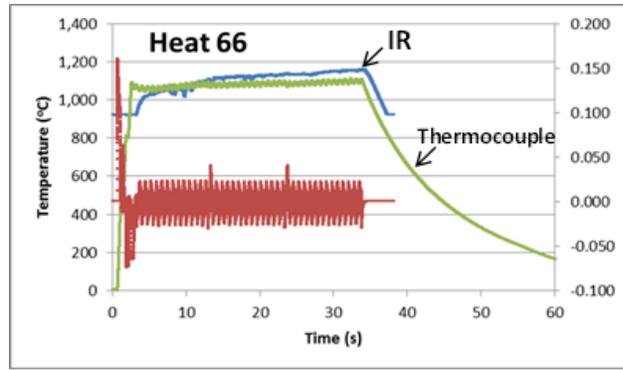
**Figure 7. Temperature Measurements from Both IR Camera and Thermocouple Overlaid with the AC Current Pulsation Profile for a 33-s Heat Treatment**

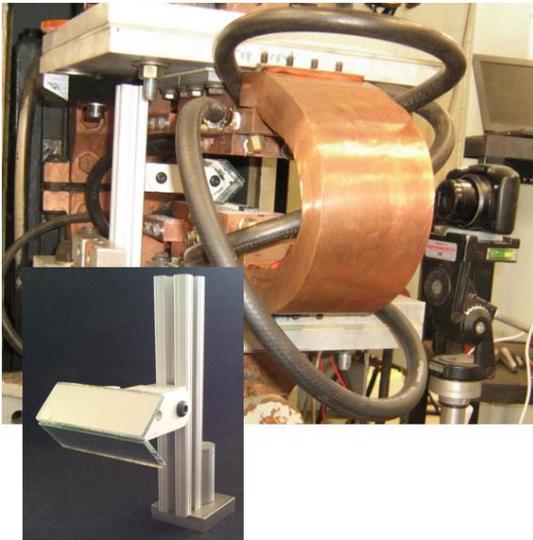
**Figure 8. Apparatus for In-Situ Photographing Opposing Electrode Faces** (insert shows the double mirror used to simultaneously photograph top and bottom heating elements)

Monitoring of heating element face conditions was done using a set of mirrors combined with a digital camera. The mirror system allowed photographing of upper and lower faces of the ceramic at specific intervals during the durability testing. This unit is shown in Figure 8. The camera was placed on a tripod and located in the identical position to repeatable imaging. Figure 9 shows an example of top and bottom electrode faces and two of the sides at the termination of a test. Independent pictures of the element faces (loose from the fixture) are also shown for comparison.

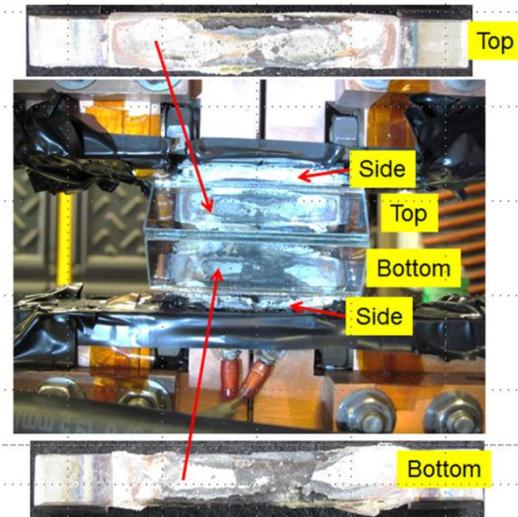
**Figure 9. Example of Electrode Face Images Taken during Endurance Testing** (superimposed are top and bottom photographs taken from the same set of electrodes after removal from fixture)

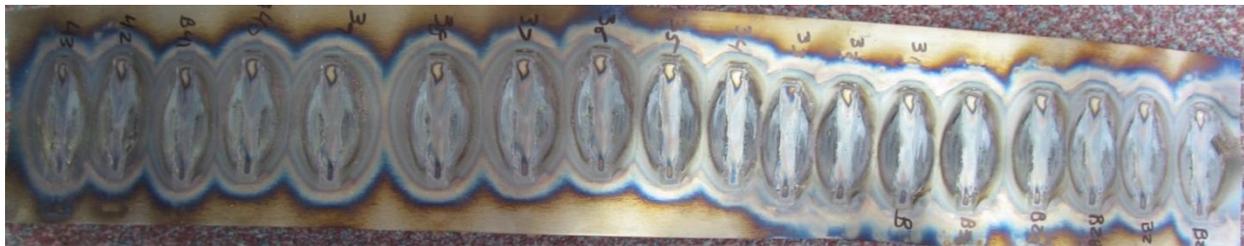
**Figure 10. Example of an IRHT Durability Test Plate in This Program**

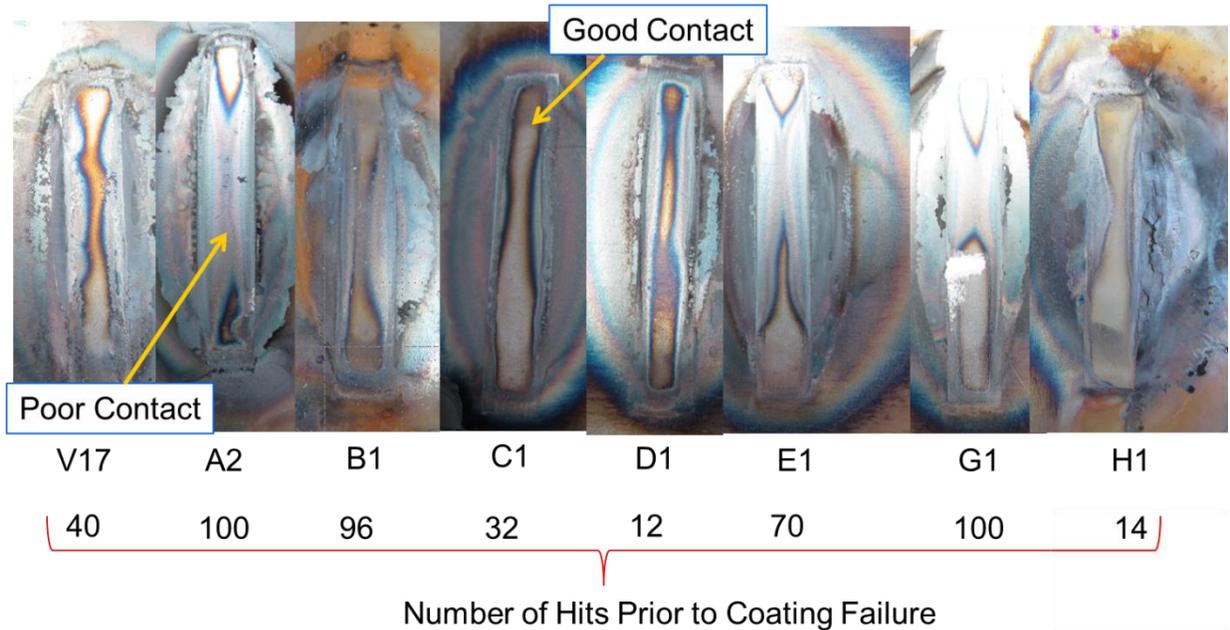
**Figure 11. Surface Quality and the Numbers of Cycles to Failure for the Various Trials Conducted in This Study** (images shown highlight differences in contact between the electrodes and the steel)

Two tests of elements using each coating type were performed at the nominal aim temperature of 1100°C. These two tests were performed at differing forces with the intention of improving thermal contact between the electrode and the steel. A table of test parameters and results is given in Table 1. Figure 11 shows the surface conditions of areas heat treated under the differing conditions of these tests. The data provided in this figure includes the trial designation and the numbers of hits to failure (number of thermal cycles) for the different coatings and force levels.

The durability testing of the baseline YSZ ceramic coating (Series G) was conducted to the limit of 100 cycles. Progressive coating removal across element face was noted. The low force variant of the YSZ coating (Series D) was terminated after only 12 thermal cycles due to excessive heating and melting at the center of the steel strip. This was accompanied by a decrease in the measured temperature over these thermal cycles. The  $\text{Al}_2\text{O}_3$  ceramic coating (Series A) tested at low force failed by excessive wear produced by progressive spallation of coating from the face after 100 thermal cycles. A high-temperature variant failed after 98 hits due to cracking of the TZM. In both cases, the temperature of the element increased toward the end of the durability testing. The mullite coating without a bond layer (Series E) tested at high force failed by overheating at the TZM/ceramic interface after 70 thermal cycles. This resulted in the melting of steel under the heating element. The low-force variant (Series V) failed after 40 cycles due to progressive spallation across electrode width. Mullite with a bond coat at low force (Series C) failed at the TZM/bond coating interface after 32 heating cycles. The high force variant (Series H) failed after 14 thermal cycles by gross spallation of the mullite from the base coat.

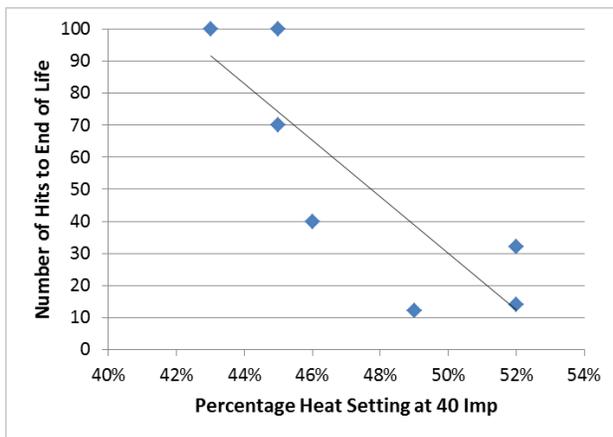
**Figure 12. Comparison of Coating Life with Power Level During Testing** (%heat shown represents the voltage in the last power pulse in the process)

temperature of the heating elements. This is summarized in Figure 12. Here, power level is defined by the voltage (shown as a %heat) to maintain the desired temperature in the final pulse. Those trials requiring higher power levels at the end of the heating schedule to achieve the aim temperature were correlated with reduced life of the ceramic. It was further noted that the lower power trials correlated with those using reduced contact forces, which in turn implied poorer contact between the heating element and substrate. The trials with improved electrode contact may have better heat transfer from the steel into the ceramic, resulting in an increase in power demand and thus coating degradation.

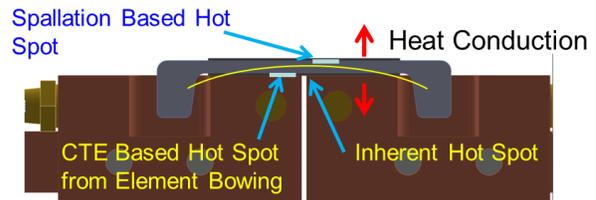
**Figure 13. Potential Distortion of the Heating Element during Processing** (slight bowing in the electrode may alter the heat conducted to the copper fixture and create a hot spot due to spallation of coating)

A related degradation may also occur because the heating element may have mechanically bowed or twisted. Figure 13 illustrates a possible orientation of bowing in the electrode as a means of altering the heat conducted to the copper fixture. This could be caused by linear expansion of TZM element constrained in the tooling. The resulting bowing can cause both hot spots due lack of contact with the fixture, as well as surface strains leading to coating fracture.

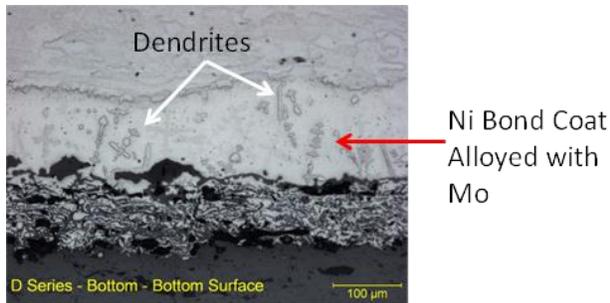
**Figure 14. Formation of Liquid at the Interface between the Ni from the Bond Coat and Mo from the TZM**

Spallation was observed primarily as poor coating adherence between the various layers of the deposit. Spalling of the coating may have been caused by several reasons. It is possible that the base layer could interact with the TZM to liquate and cause spalling. Other possible examples are liquation cracking ( $\text{MoO}_3$ , MoNi, or Cr-based) along grain boundaries in the ceramic. An example of a liquid forming between the ceramic and substrate (here caused by the interlayer reacting with the TZM) is shown in Figure 14. Evidence of how such liquids can penetrate the coating grain boundaries and cause cracking is provided in Figure 15.

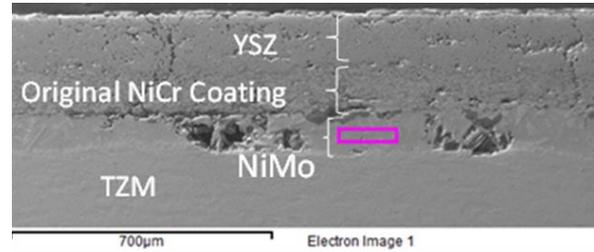
**Figure 15. Example of Constitutional Liquation and Subsequent Cracking of the Ceramic Coating**
