A Guide to Failure Analysis for the Oil and Gas Industry

*Alber Sadek, Senior Engineer
EWI*

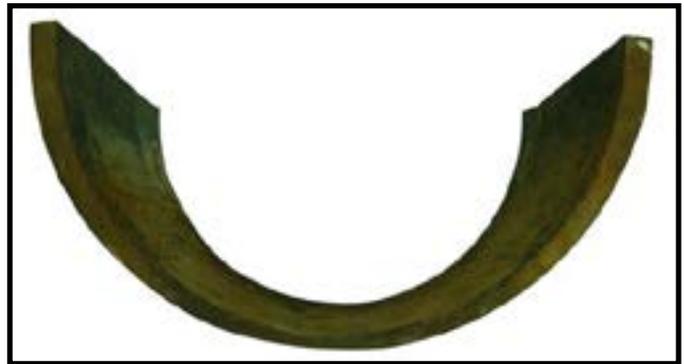
Corrosion Failure Case Study 1: Figure 1 shows a severe reduction in the thickness of a 20-in. diameter carbon-steel spool with an original wall thickness of 20 mm. This specimen was removed from a natural-gas production facility after 9 months of operation. The 65% reduction in wall-thickness occurred in the bottom section of the pipe as shown in Figure 1, resulting in a final wall thickness of just 7mm. All operating parameters and pertinent service information were collected and a complete metallurgical analysis was carried out.¹

Figure 1: 65% thickness reduction of a 20-in. diameter carbon-steel pip after nine months of operation.

Test results indicated that the rapid reduction in thickness could be attributed to three simultaneously occurring mechanisms. First, erosion was caused by hard particles in the natural gas under the working flow rate and pressure. Second, corrosion contributed to the failure as a result of: (1) the presence of a large 6mm misalignment between the two pipe sections, (2) the pipe's horizontal service orientation and its location within the overall piping system, and (3) the presence of H₂S in the natural gas (13 PPM), which may have been increased at the condensate, forming dilute sulfuric acid and

resulting in corrosion. Third, material softening (cementite dissolving) occurred due to the applied forces during manufacturing of the spool. This can be seen in the measured hardness values. The hardness of the inner surface was 66% of the outer surface, resulting in lower wear/erosion resistance.

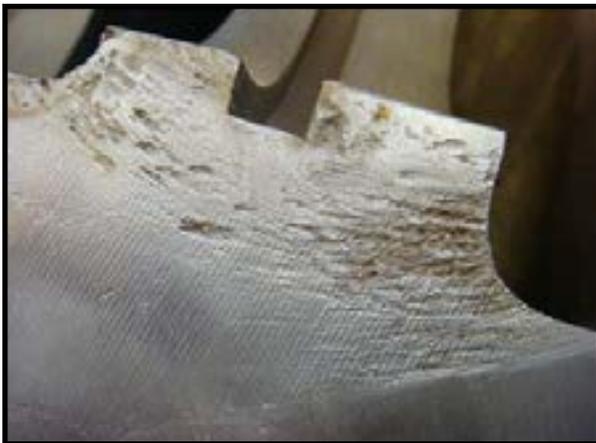
Corrosion Failure Case Study 2: An example of a wear failure in natural gas field equipment is provided in Figures 2 and 3. This lean-solution pump was opened to investigate a vibration issue, revealing a number of problems. An excessive clearance of 2.2 mm due to wear was measured between the balance drum and the throttling push. The required clearance in this area is specified as 0.33 mm to 0.41 mm. Further, unexpected pitting and wear was present in all impellers, intake, shrouds and blades. Erosion wear was also observed in the pump casing at the mating faces of the upper and lower halves as shown in Figures 2 and 3.

Figure 2: Erosion wear, pitting, and cracking in the pump casing of a lean-solution pump.

The failure analysis included a complete examination of the fracture surface using a stereoscope, optical and scanning electron microscopes, energy dispersive spectroscopy, chemical analyses, and microstructural evaluations. Based on the investigation carried out on the provided pump components, gas analysis data, and

contaminants collected from the upstream filter, the damage was attributed to three causes². First, the erosion of the impeller surface was caused by hard particles in the solution, with vanadium oxide acting as the key oxide-breaching mechanism. Second, elemental mercury in contact with the stainless-steel material induced rapid corrosion. When mercury is present in its elemental form, it can cause catastrophic damage in stainless steel through an adsorption mechanism, especially if the chromium content is significantly higher than the nickel content, as was the case in this example. Third, cavitation erosion was responsible for the relatively high wastage rates and the development of pitting and craters during service (Figure 4).

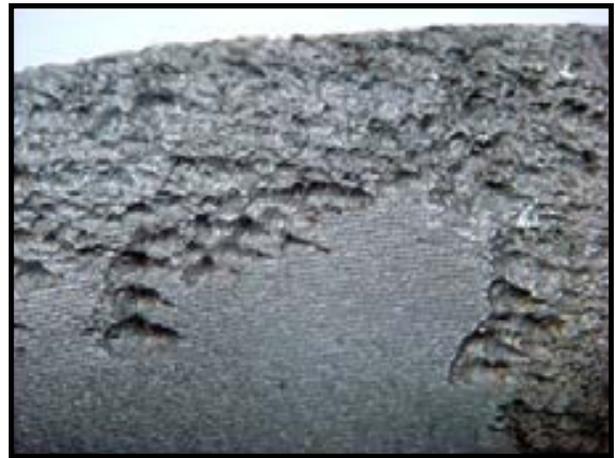
Figure 3: Evidence of the direction of flow on the eroded impeller surface.

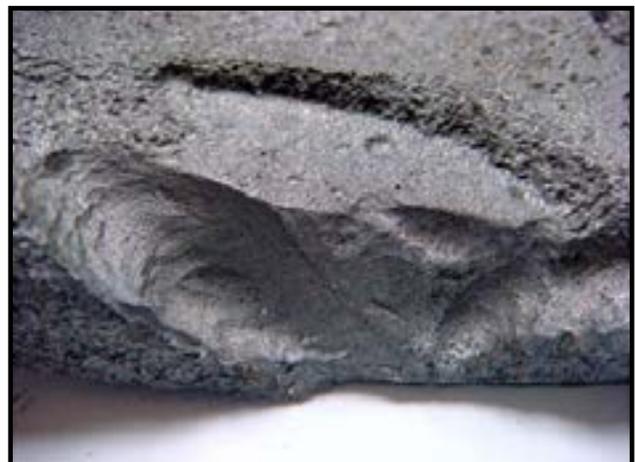
Figure 4: Pitting and craters on the damaged surface.

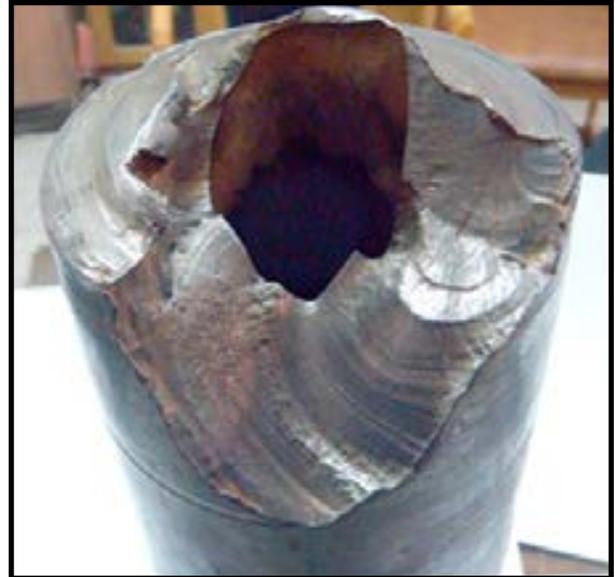
Fatigue Failure Case Study: Figures 5 and 6 show a drive shaft fracture which occurred after 245,000 revolutions with the fracture surface containing typical fatigue fracture zones. Two cracking initiation zones are present, characterized by a striation pattern. A step-patterned propagation zone can be seen in Figure 5, as can the overload fracture zone. Finally, a zone with a ground and smoothed surface is present opposite to the crack initiation side, resulting from a severe friction force at the rotating fracture faying surface after failure, indicating that one end of the drive shaft had stopped rotating.

Figure 6: General view of the failed drive shaft after approximately 245,000 revolutions.

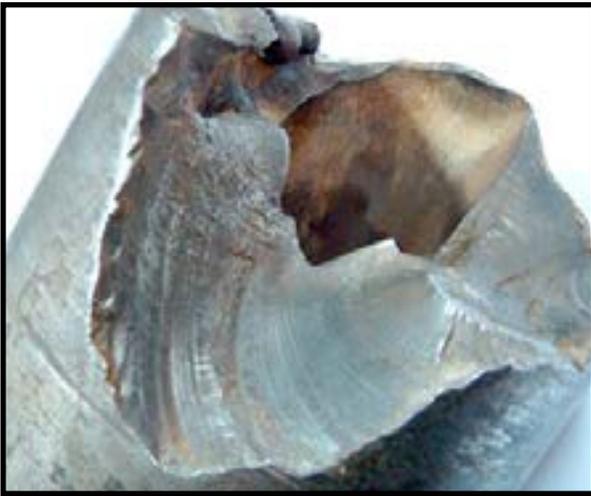
Figure 7: Step pattern fracture zones in the failed upper drive shaft.
