EWI Capabilities to Support the Midstream Pipeline Industry

Improvements in Corrosion Assessment Methodologies

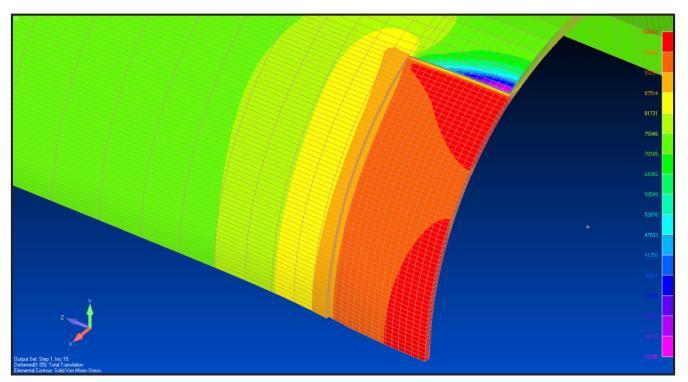
Figure 1. Local contour plot of the von Mises stresses in and around a deep corrosion patch near onset of failure. Note bulging remains within the defect area.

As an example of the modeling effort, Figures 1 and 2 illustrate the stress condition at the predicted burst pressure for flat-bottomed corrosion patches,

one shallow and one deep. These figures show that the bulging behavior remains generally isolated to the corrosion patch with little load shedding to the surrounding pipe. The bulging behavior, whether it remains local within a defect area or extends out into the main pipe body, is controlled by the corrosion defect geometry, internal pressure and the pipe steel properties.

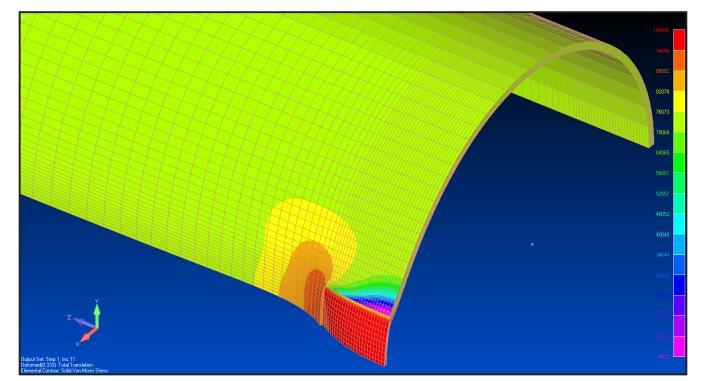
Figure 2. Local contour plot of the von Mises stresses in and around a shallow corrosion patch near onset of failure. Note bulging begins to extend outside the defect area.

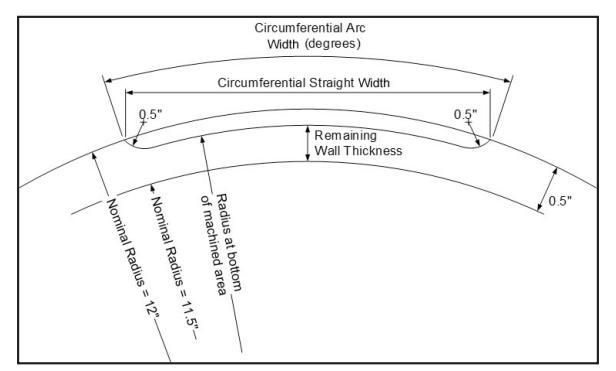
Figure 3a. Schematic showing approach to machining simulated corrosion defects for full-scale tests.

to validate the predicted failure pressure and failure behavior (leak vs. rupture). The test pipes contained simulated flat-bottomed corrosion defects by machining patches as shown in Figures 3a and 3b. The pipes were made monotonically and pressurized to failure with the actual failure pressure and failure type – whether the failure was contained within the defect patch or not compared with the models. Figure 4 shows one of the full-scale test pipes with the failure remaining within the defect patch area. The result of these analyses provides pipeline operators with enhanced tools for assessing operating pressure, pipe properties and corrosion defect sizes to the likelihood of a rupture or leak.

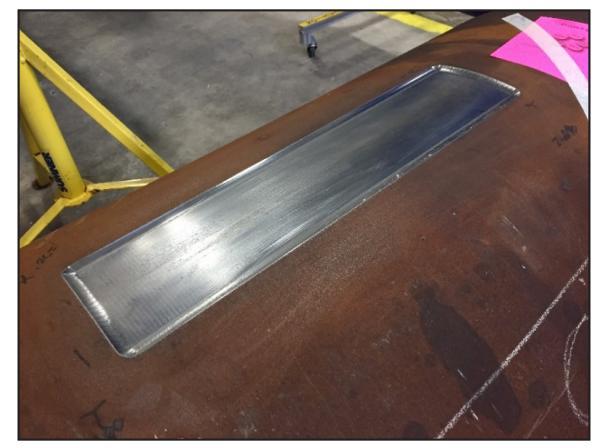
Figure 3b. A machined, simulated corrosion patch on a fullscale test pipe.

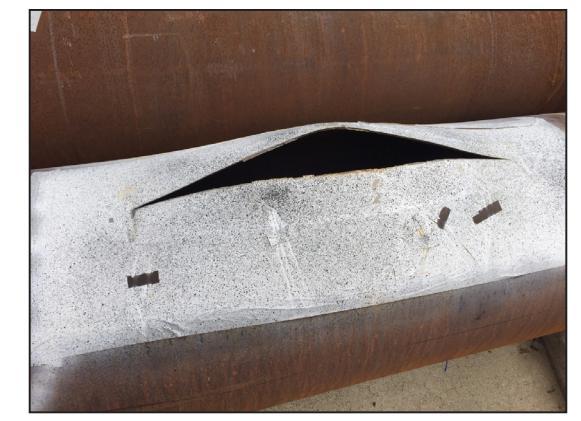
Figure 4. A burst test specimen with a leak in a machined defect patch.

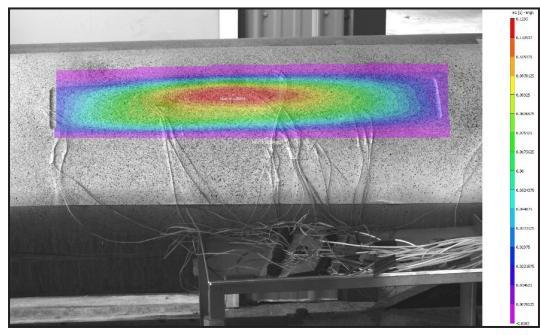
Figure 5. Full-scale burst test with digital image correlation scan showing strain localization in a machined defect patch just prior to failure. The defect patch area contained a series of strain gages with the strain gage wires shown extending around the pipe.
